[The 2015 Gorkha Nepal earthquake: insights from earthquake damage survey.](#)

*Frontiers in Built Environment* 2015, 1(8), 1-15

# The 2015 Gorkha Nepal earthquake: insights from earthquake damage survey

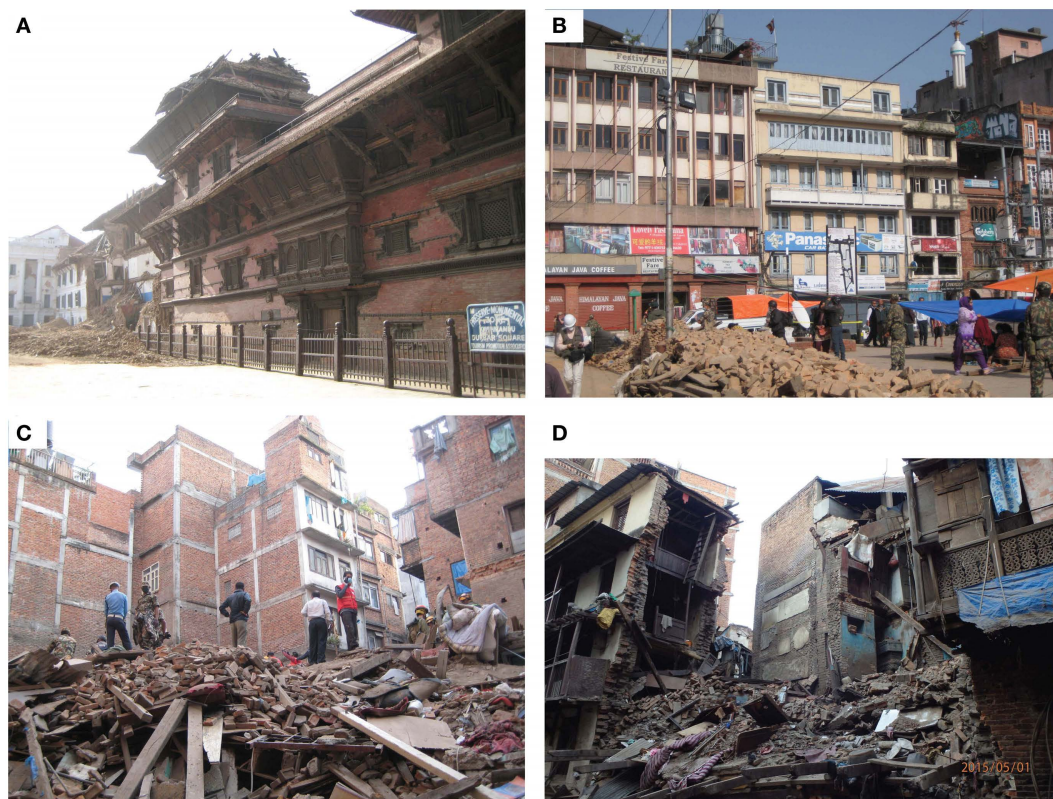
**FIGURE 8 | Damage in Kathmandu (area 1 in Figure 4). (A)** Collapse of the Basantapur Tower in the Kathmandu Durbar Square. **(B)** Undamaged buildings opposite of the Basantapur Tower in the Kathmandu Durbar Square. **(C)** Collapse of four 5- or 6-story old masonry buildings. **(D)** Collapse of a 4-story masonry building.

Many historical buildings in the Kathmandu Durbar Square (in front of the Old Royal Palace of the former Kathmandu Kingdom and is a UNESCO World Heritage site) were devastated (area 1 in **Figure 4**). **Figure 8A** shows the collapse of the Basantapur Tower. The complete destruction in the Durbar Square was in sharp contrast with undamaged buildings surrounding the Durbar Square (**Figure 8B**; several wall cracks can be found on these buildings;

however, the majority of the masonry buildings are structurally stable). This indicates that the ground shaking experienced in this area (note: this is relatively close to the KATNP station; see **Figure 4**) was sufficient to cause the collapses of the old historical buildings but was not to cause severe damage to the surrounding buildings. This observation was confirmed by walking through the Indra Chowk area (market squares near the Old Palace), where many old masonry buildings (three to six stories) were densely constructed. Nevertheless, there were several buildings that collapsed completely and some search and rescue activities were undertaken (**Figures 8C,D**).

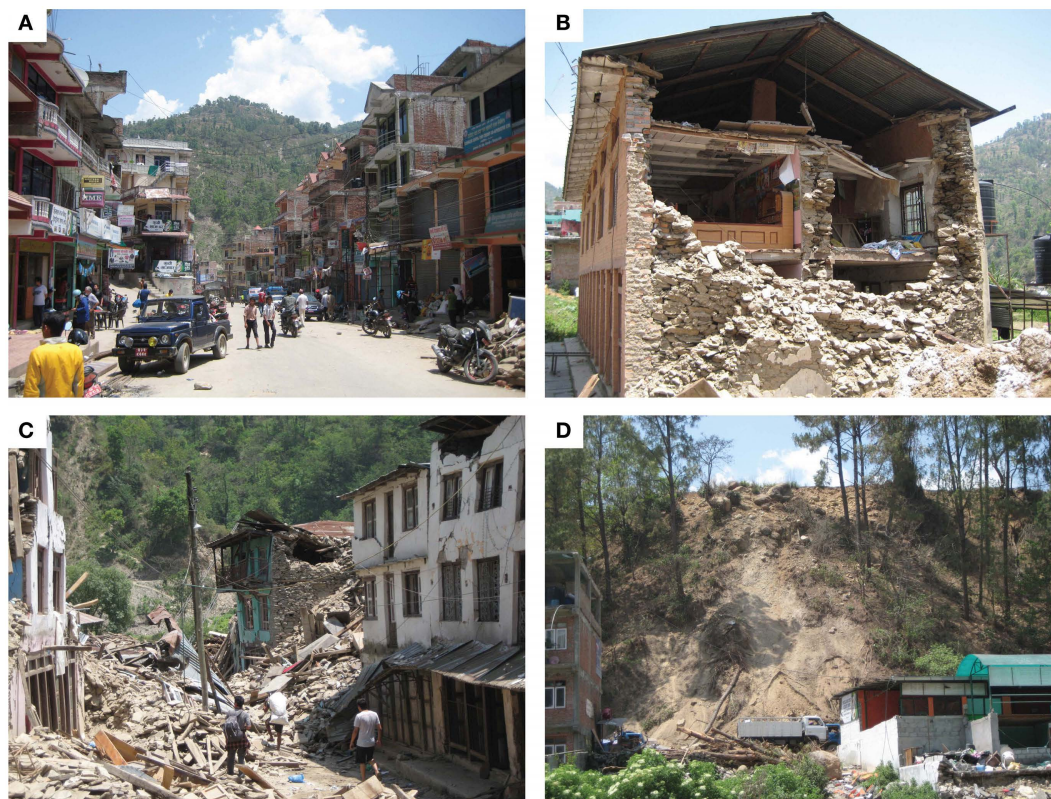
**FIGURE 10 | Damage in Melamchi (see Figure 3). (A)** Main street in Melamchi. **(B)** Damaged stone masonry house. **(C)** Devastated street in Melamchi. **(D)** Shallow landslide along the main road.

street of Melamchi was not completely destroyed (Figure 10A); most buildings looked undamaged based on their appearances, although several buildings were collapsed. On the other hand, buildings along a side street were devastated by the earthquakes (Figures 10B,C). The majority of the damaged buildings were made of brick and stone. Along the road, several sections of the slope suffered from shallow landslides (Figure 10D), their debris blocked the road at one time but was removed. There was a steel truss bridge with RC deck for vehicle crossing; the bridge was not damaged (inspected from backside). It has been reported that

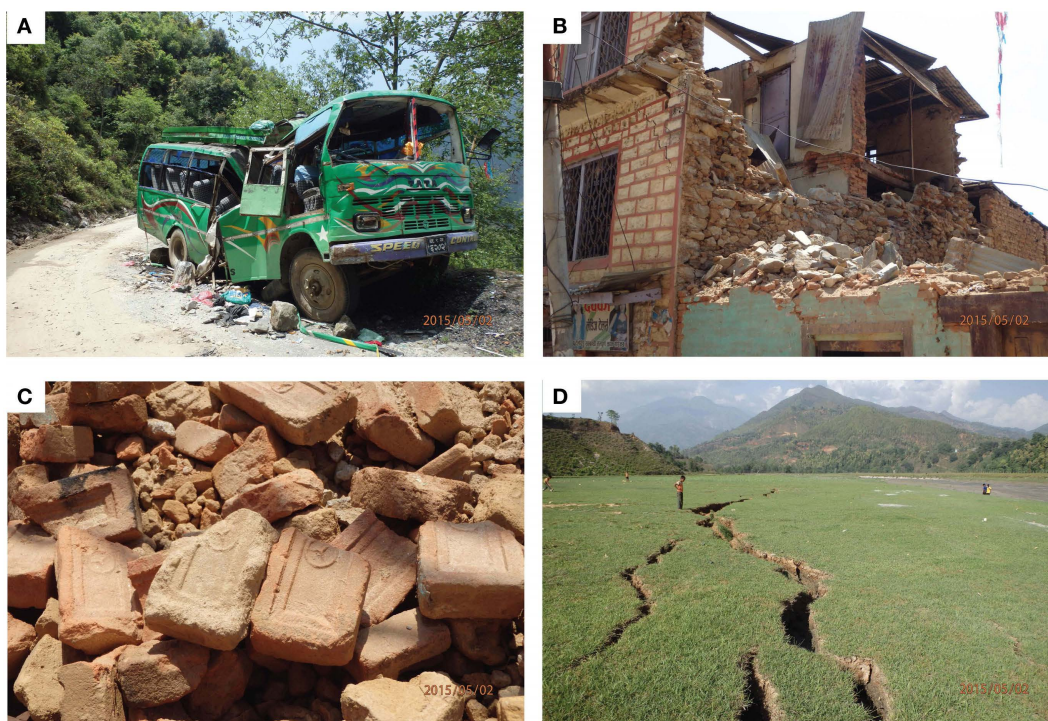
**FIGURE 11 | Damage in Trishuli (see Figure 3). (A)** Destroyed bus due to boulder fall. **(B)** Damaged brick masonry house in Battar. **(C)** Different types of bricks used in the damaged masonry house in Battar. **(D)** Ground fissures in the Trishuli dam reservoir.

In Trishuli, there was an earth fill dam for hydroelectric power generation. The main body of the dam was the excavated and compacted soil. The height of the dam was 12 m (upstream side) and 20 m (downstream side), and the crest width was about 4 m. Due to the earthquake, there were cracks at upstream side of the dam and fissures on the crest. Moreover, liquefaction (as evidenced by silt boils) and lateral spreading (**Figure 11D**) occurred inside of the dam reservoir due to the earthquake. The operation of the power generation had been suspended since the

following day of the mainshock; at the time of the visit, no power was available in nearby villages. Overall, the earthquake damage to the Trishuli dam will not cause severe problems immediately. However, the extent of cracking along the dam axis may suggest a deterioration of the dam body, which may be accelerated into the dam failure by future earthquakes or penetration of rain water into the dam body through cracks. It is important to mention that in worst-case scenarios (note: this earthquake is not the extreme case in terms of ground shaking intensity), catastrophic dam failures could have been caused. As there are several major hydroelectric projects along the Trishuli River as well as in other major rivers in Nepal, ensuring dam safety against large earthquakes is important.
